## Proper placement of plastic barb on bottom of xSystem

### Advisory Note

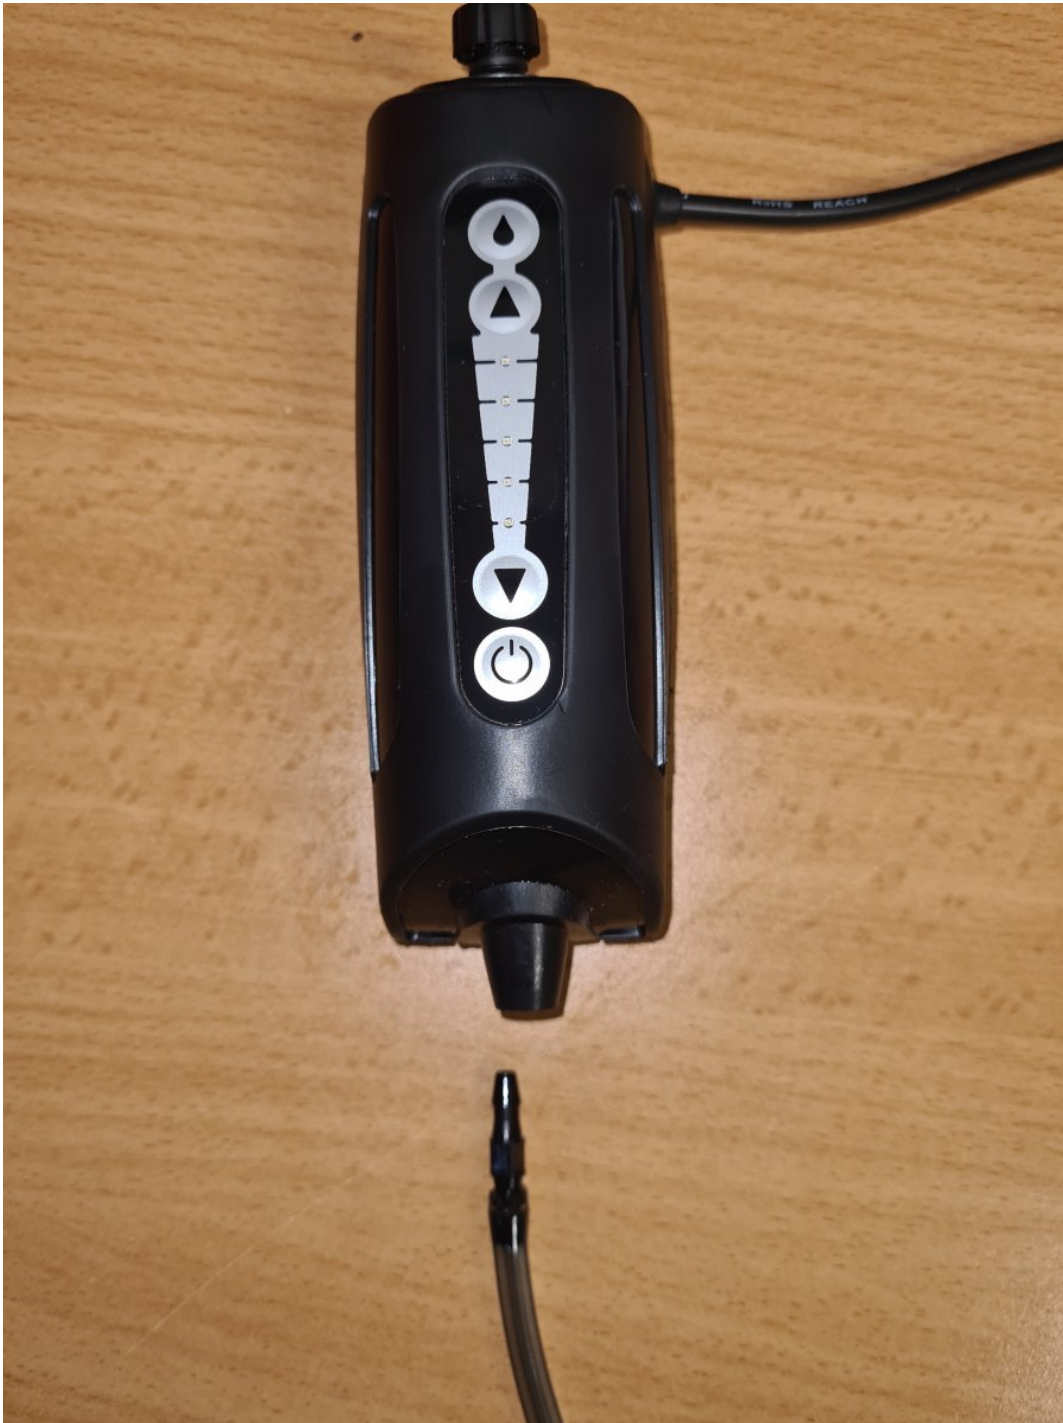
Below is the plastic barb fitted to the delivery tubing and ready to fit to the bottom of the xSystem

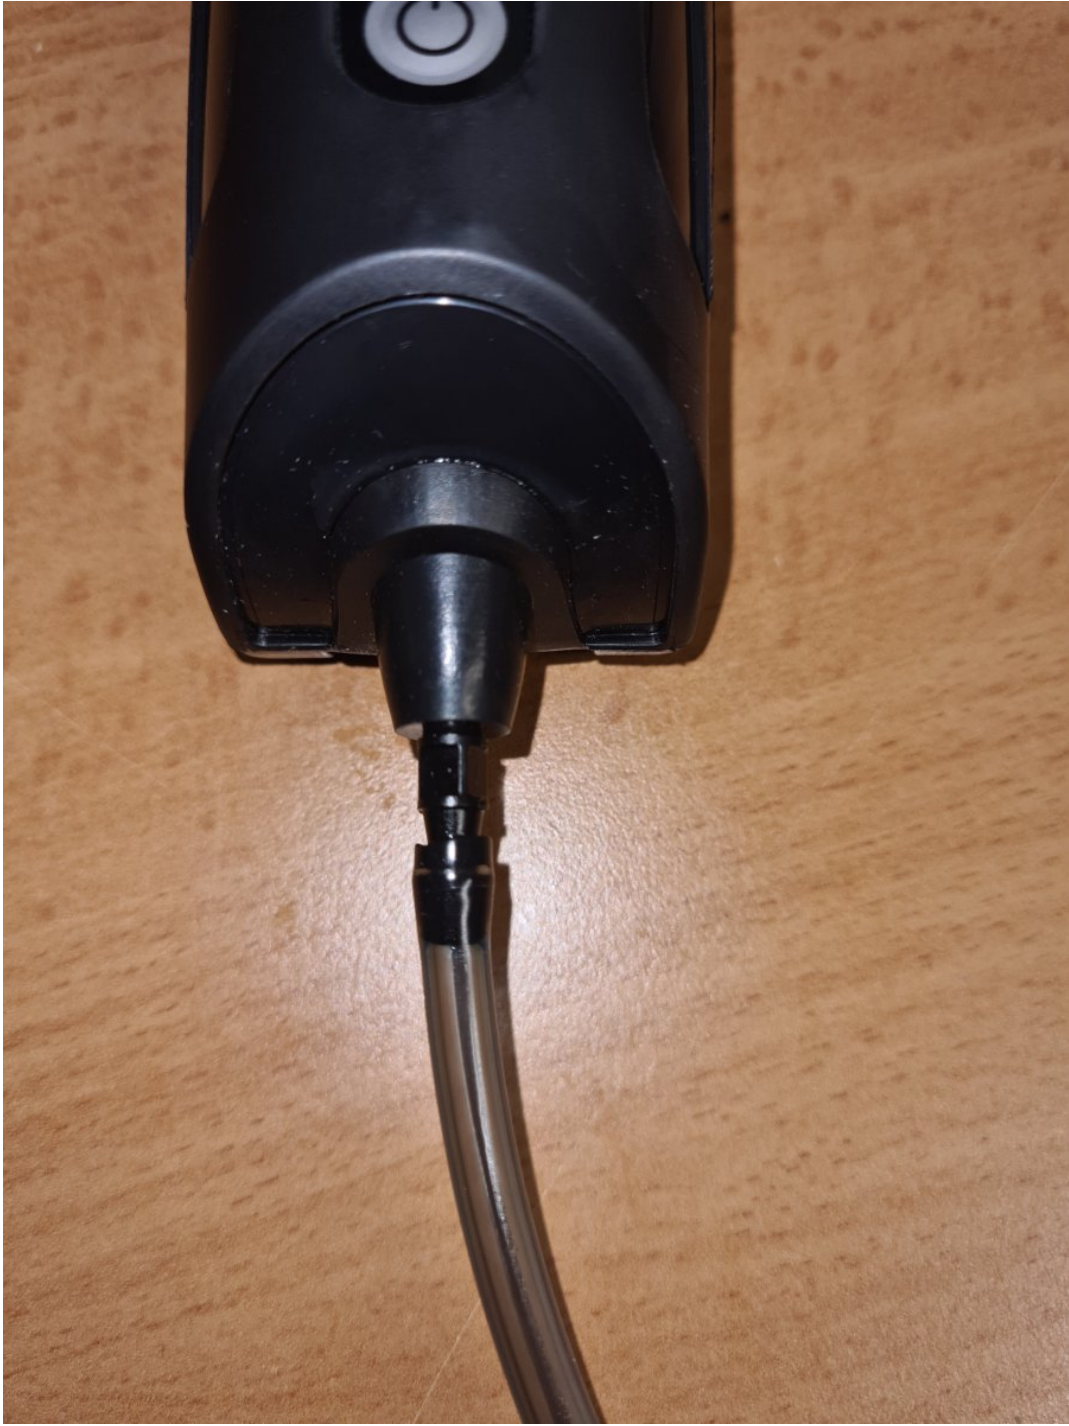
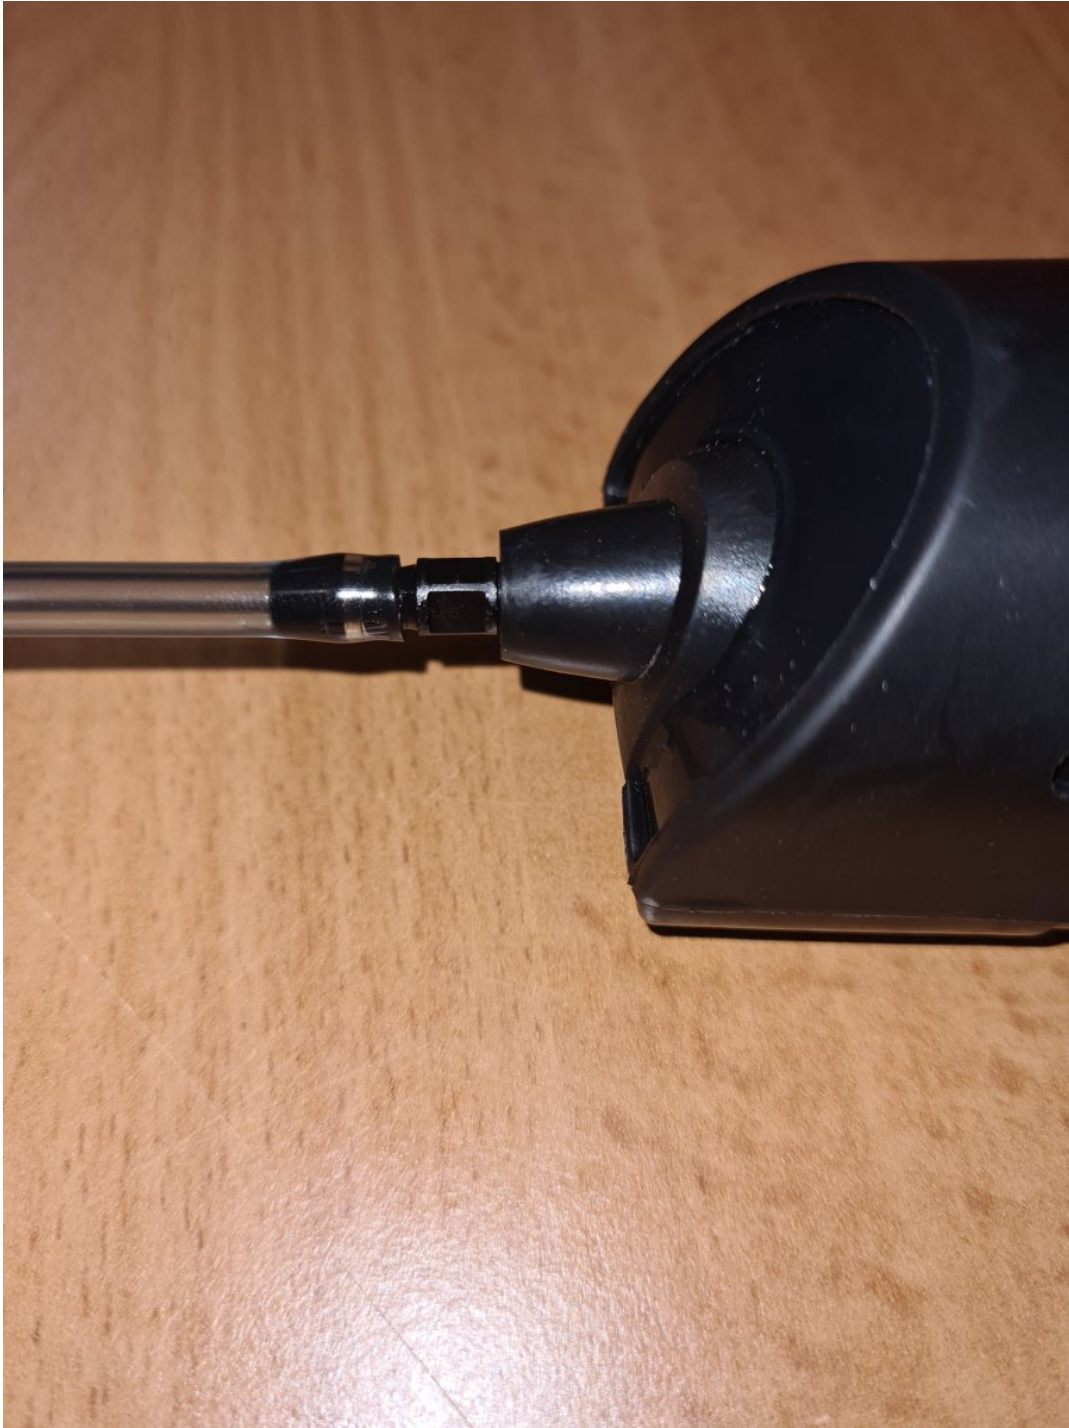
**Correct Fitment below - you should still be able to see the square section of the barb.**

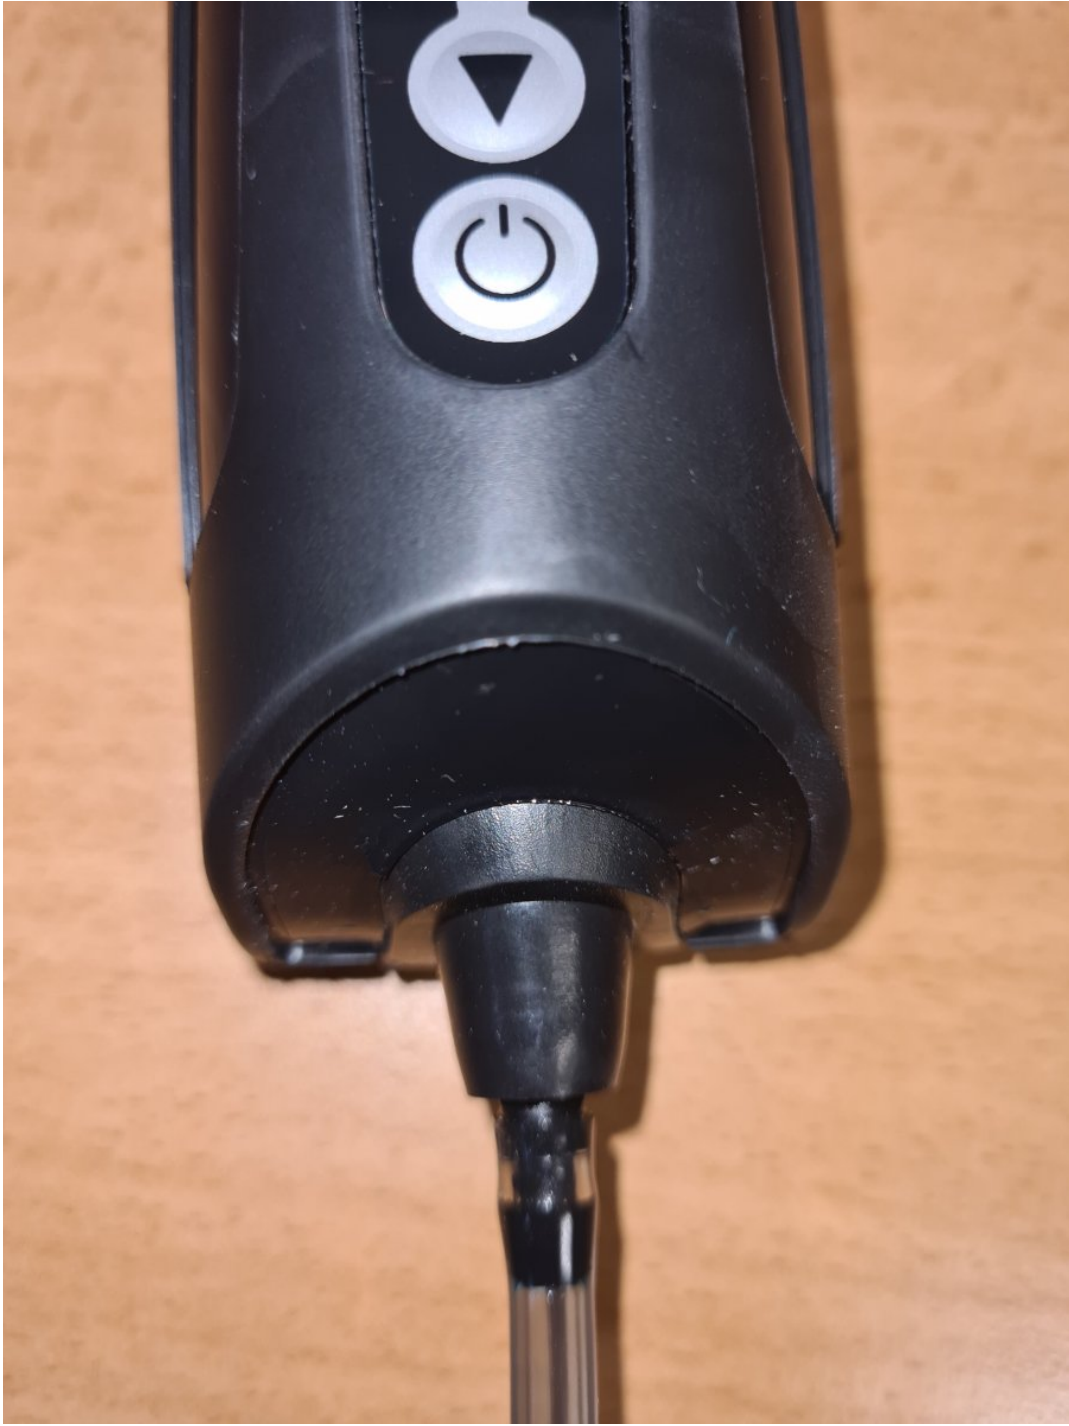
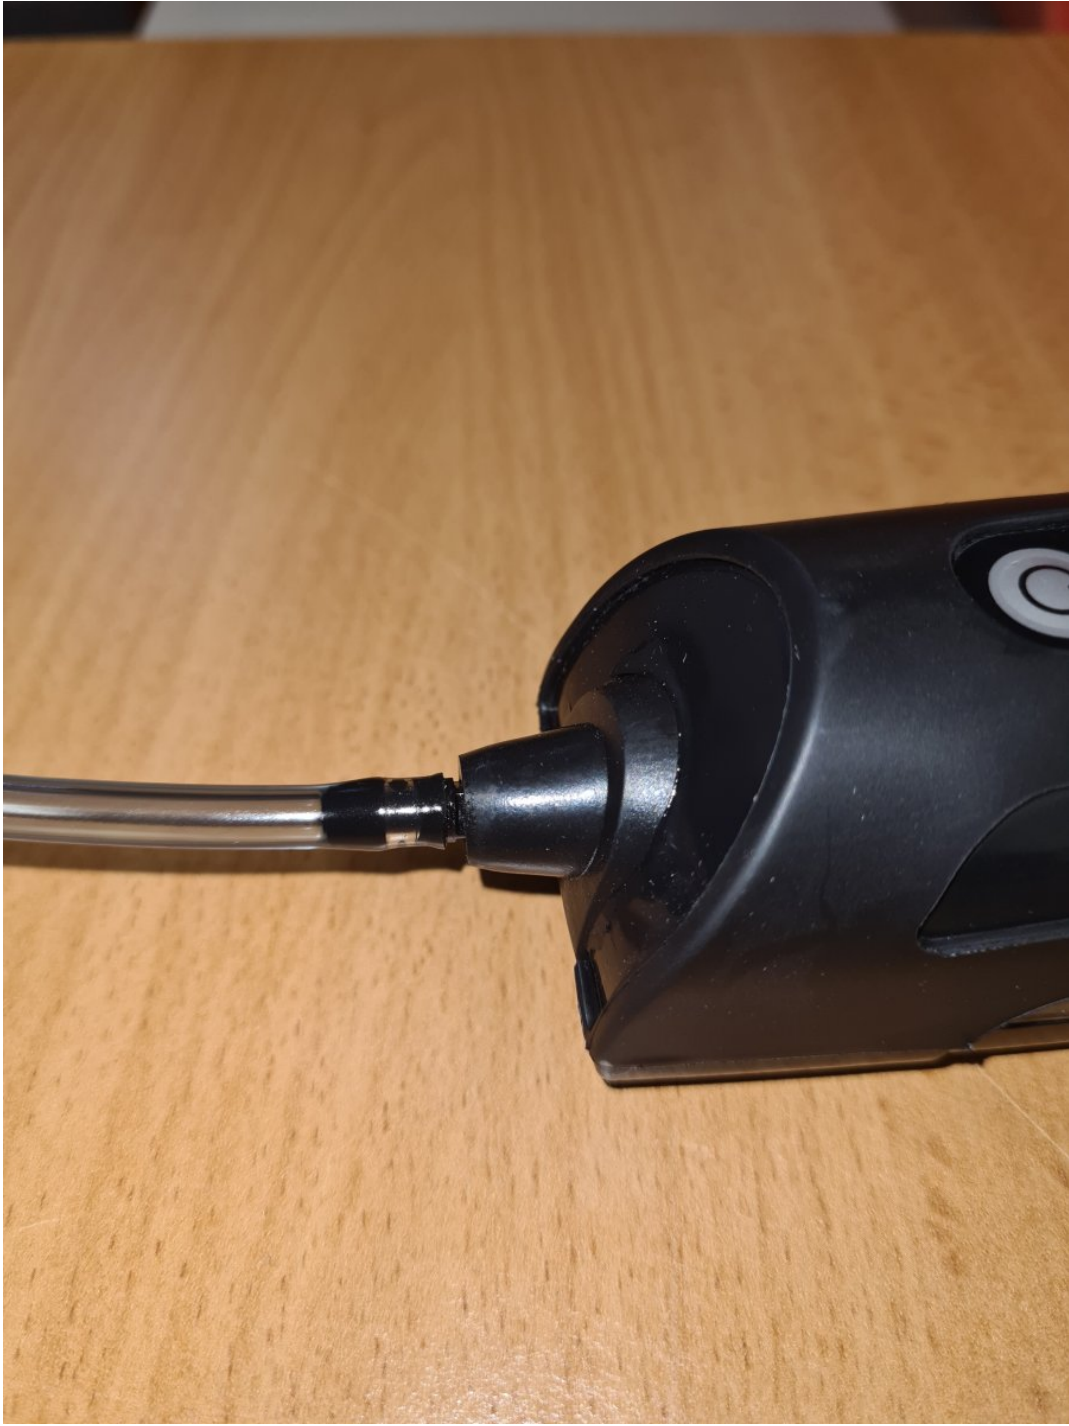
**Incorrect fitment below**

Some customers have been inserting the barbed connector too far into the bottom of the xSystem, this puts strain on the pump and internal seals and can cause leaks from the bottom of the unit.
